Rapid Assessment of Earthquake Threat Vulnerability in Campus 3 of University of Technology Yogyakarta Based on Android Application

Dwi Kurniati ^{*, a,1}, Eka Faisal Nurhidayatullah ^{b,2}, Samsul A Rahman Sidik Hasibuan ^{c,3}

^{a,b} Department Of Civil Engineering, Universitas Teknologi Yogyakarta, Yogyakarta, Indonesia

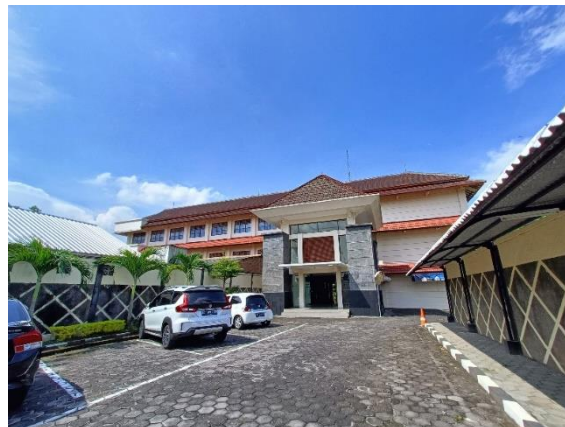
Figure 4. Campus Building 3 Section 1

The public building has 3 floors and has a land area of approximately 6,500 m² and a building area of approximately 600 m² on one floor with a total building area of 1,800 m². Campus 3 building is a building that is used as a learning center that emphasizes smart technology. It can accommodate many people in carrying out learning activities. Hence, this building is categorized as a school building that is following the form contained in FEMA 154-2015. Campus 3 building is estimated to have around 500 people visiting at the same time.

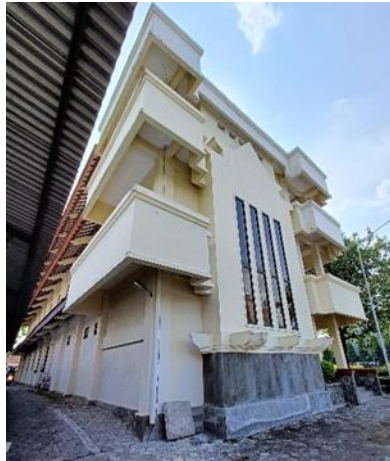
Figure 5. Campus Building 3 Section 2

The public building has 3 floors and has a land area of approximately 6,500 m² and a building area of approximately 450 m² on one floor with a total building area of 1,350 m². Campus 3 building is a building that is used as a learning center that emphasizes smart technology. It can accommodate many people in carrying out learning activities. Hence, this building is categorized as a school building that is following the form contained in FEMA 154-2015. Campus 3 building is estimated to have around 500 people visiting at the same time.
