Transforming the West Sumatra Police Hall: Retrofitting Strategies for a Multifunctional Facility

Abstract

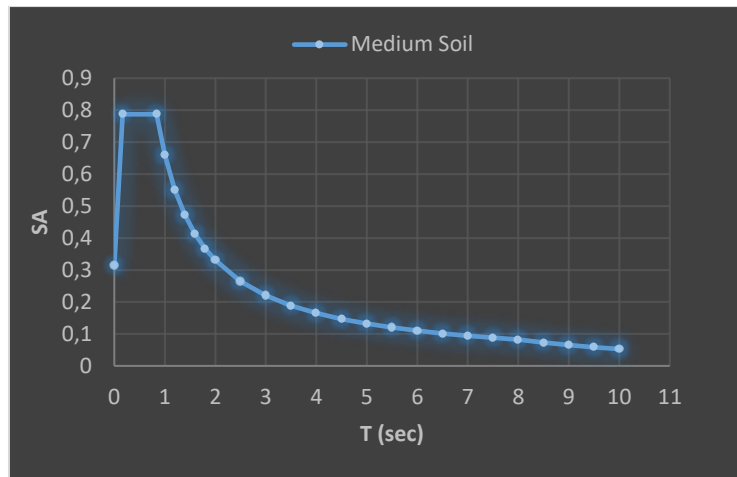
Figure 4 Spectrum Response Design for Earthquake Load in Padang based on SNI 1726:2019

The response spectrum analysis is a structural dynamic analysis method applied to the seismic response spectra of a design. It determines the spectrum response to a design earthquake through the superposition of responses for each vibration mode. This method is widely used due to its simplified approach for calculating the design strength of structures and evaluating structural systems subjected to seismic loads. In this study, the response spectrum design for earthquake loads was developed in accordance with SNI 1726:2019. Based on soil test results, the building site is classified as medium soil. Figure 4 illustrates the response spectrum design for the specific soil conditions in Padang.

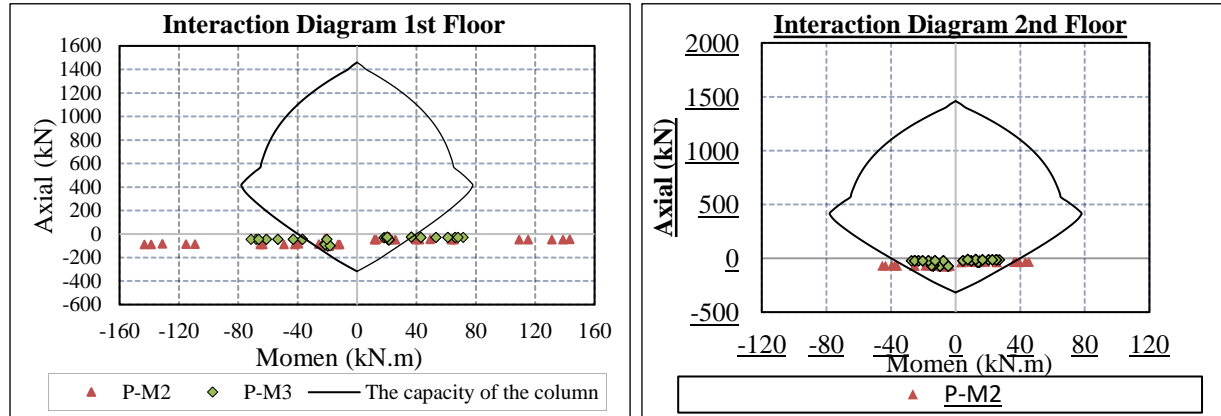
Figure 5 (a) First Floor and (b) Second Floor Existing Column P-M Interaction Diagram

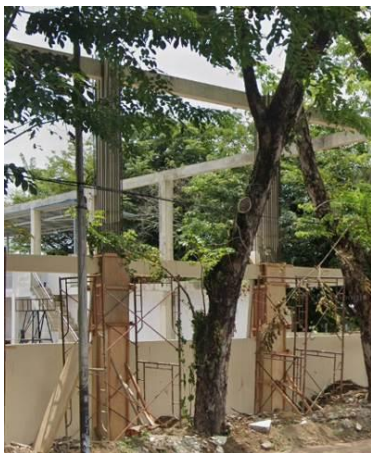
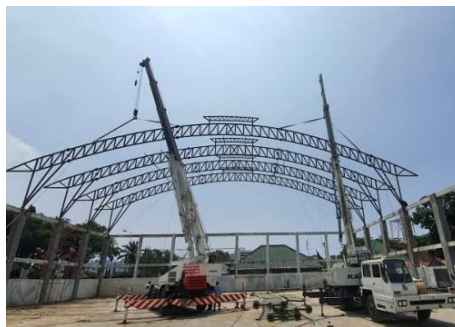
Figure 8 (a), (b) and (c) Documentation of the Reinforcement Process Using the Column Jacketing Method

The work process begins with the column, as shown in Figure 8(a). This involves cleaning the existing column, adding reinforcement, constructing formwork, and completing the process with concrete casting. After all columns have been reinforced, the cutting and assembling of the truss structure are carried out simultaneously in the factory using steel pipe materials, as depicted in Figure 8(b). Finally, the truss structure is installed on-site with the assistance of a crane, as illustrated in Figure 8 (c).

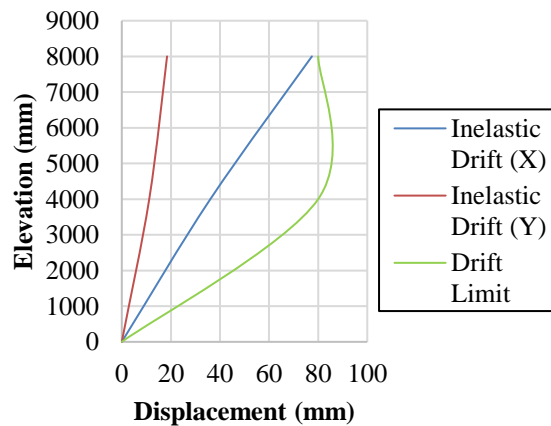
Figure 11 Story Drift Retrofitted Column

The results demonstrate the impact of reinforcement on the structural columns in controlling the inter-floor displacement of the building. The displacement values, derived from the largest displacement on each floor, are analyzed. Based on Figure 11, the graph illustrates the relationship between building height and floor displacement, showing that inelastic drift in both the X and Y directions remains within the allowable drift limits. This indicates that the observed deviations comply with the required standards, confirming that the column dimensions meet the necessary stiffness requirements.

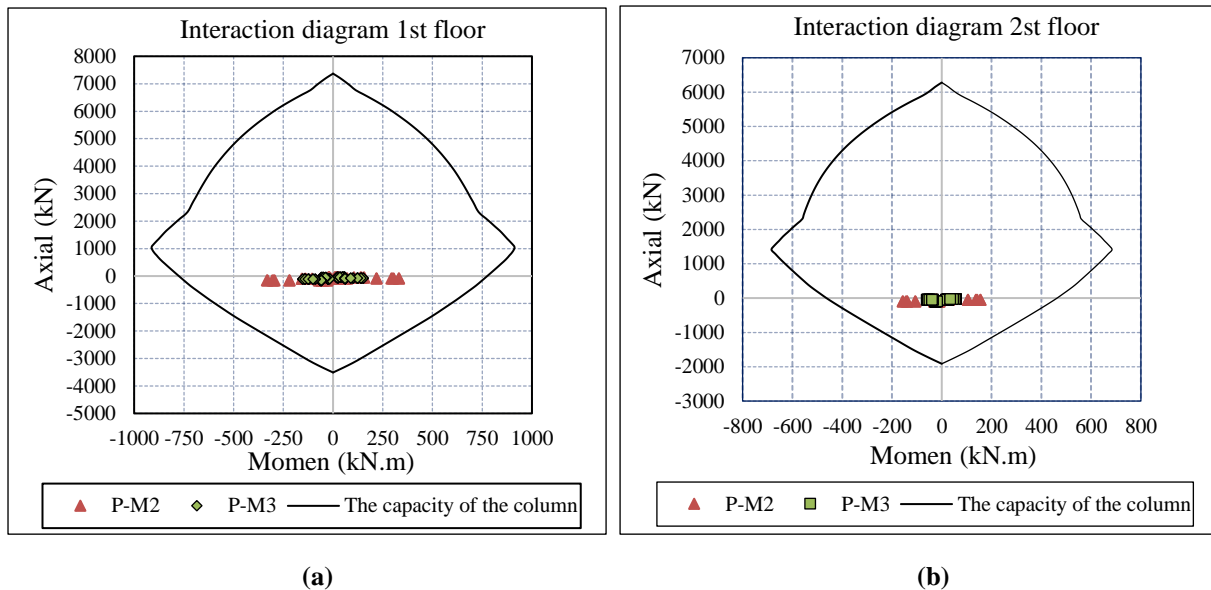
Figure 12. First Floor and Second Floor Retrofitted Column Design P-M Interaction Diagram

Based on the column interaction diagrams presented in Figures 12(a) and 12(b), it can be concluded that the columns exhibit sufficient strength to resist the forces acting upon them, both on the first and second floors. The analysis of the relationship between axial forces and moments acting on the columns indicates that all these forces

are contained within the boundaries of the column interaction diagram. This demonstrates that the column design effectively accommodates the combined effects of axial and moment loads, ensuring structural stability and compliance with safety criteria.

The column interaction diagrams provided in Figures 12(a) and 12(b) illustrate that the retrofitted columns at both the first and second floors exhibit sufficient strength to resist the forces acting upon them. These diagrams depict the relationship between the axial forces and bending moments, and the analysis reveals that all these forces are well within the boundaries defined by the column interaction diagram, which indicates that the columns are designed to effectively handle the combined effects of axial and moment loads. This further affirms that the columns are structurally capable of maintaining their stability under the applied loads. As the forces do not exceed the limits defined by the interaction diagrams, the design demonstrates that the columns not only satisfy the requirements for structural integrity but also comply with the necessary safety standards. Thus, the retrofitting measures are proven to be effective in ensuring the columns' ability to resist these loads without risk of failure, ensuring both the durability and the safety of the structure.
